found no evidence that my engine mount—that web of steel tubes that supports the engine and nosegear on my 1960 airframe—had ever been overhauled or recertified.

# Removing and sending the mount out for repairs

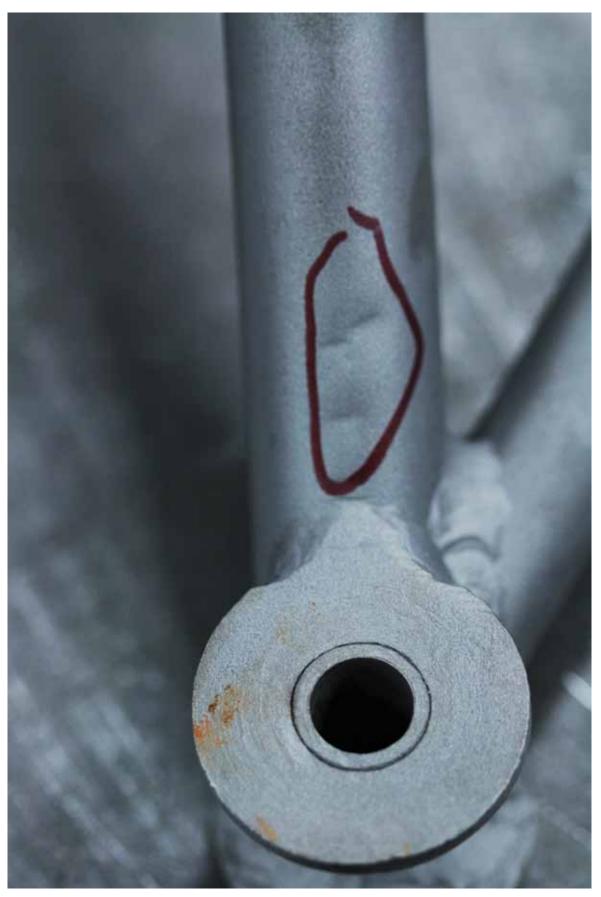
Dents are repaired during the Loree Air rework. According to Steve Loree, the circular slot around the bolt hole is how moisture—a cornerstone of the rust process—enters the tubing in the mount. Loree seals this slot during rework.

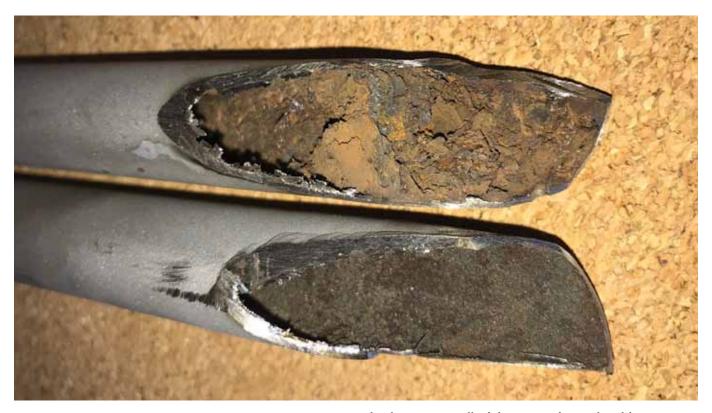
Rust was clearly present in all of the seven tubes replaced by Loree Air.

Then I saw pictures of the inside of those tubes. They were all rusted to one degree or another. I believe good fortune was smiling on me when I found the crack that lead me to remove my mount to send it for repair.
